The 2021 (VDEC) Randolph Center, VT - LDS Project included (2) days of contracted leak detection services within the distribution system. The survey provided coverage on the entirety of the town as well as VTC owned assets due to the shared system between both entities.

### Leak Card 1

# Enigma Test Report

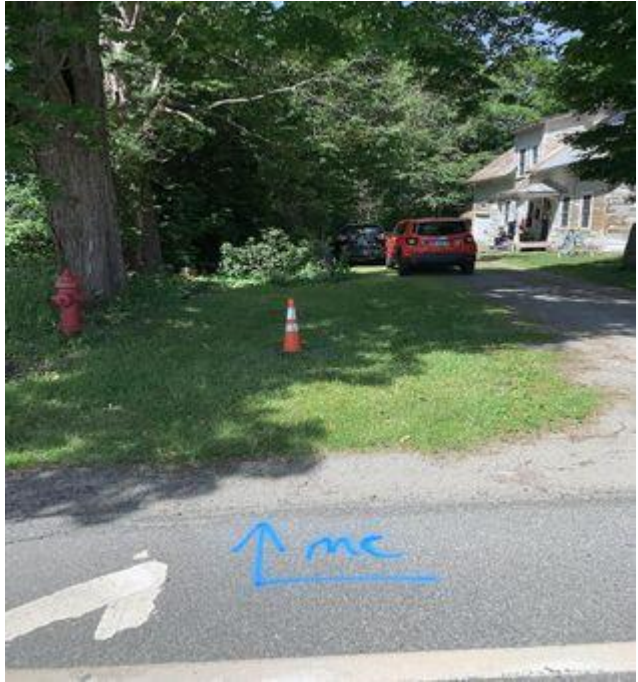
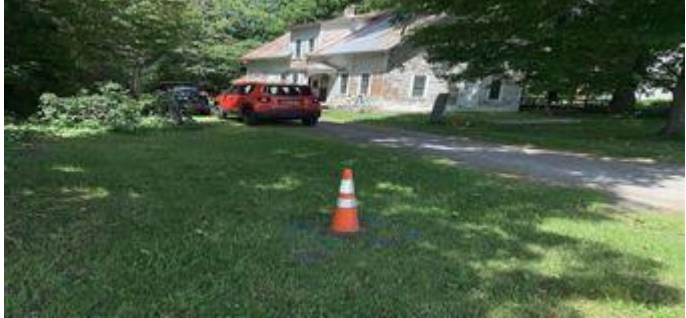
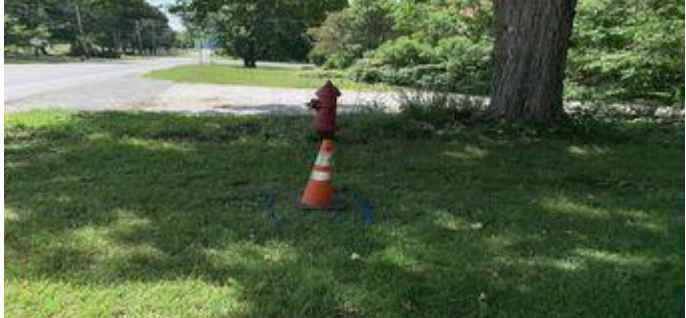
<b>Project:</b>	Randolph Center, VT - VDEC 2021 Leak Detection Investigation				<b>Address:</b>	2975 Ridge Rd			
<b>Urgency:</b>	Minimal	<b>Surface Material:</b>	Grass	<b>Leak Type:</b>	Fitting	<b>Pipe Size:</b>	6	<b>Pipe Material:</b>	DI
<b>Leak Detection Method:</b>	Sounding Visible Observation		<b>Visible Water:</b>	No	<b>DB level:</b>	62	<b>Person Submitted To:</b>	Mr. John Lens	
<b>MPT Estimated GPM</b>	<b>Gallons Per Minute:</b>		0.1		<b>Vicinity Map</b> -72.60725 43.94173 Leak

<b>Gallons Per Day:</b>		144						
	<b>Gallons Per Month:</b>		4,380						
	<b>Gallons Per Year:</b>		52,560						
<b>Leak Description &amp; Comments:</b>									
Fitting leak detected via sounding equipment. Further probing inspection found water signatures inside the valve casing. Leak appears to be at or near the valve assembly.

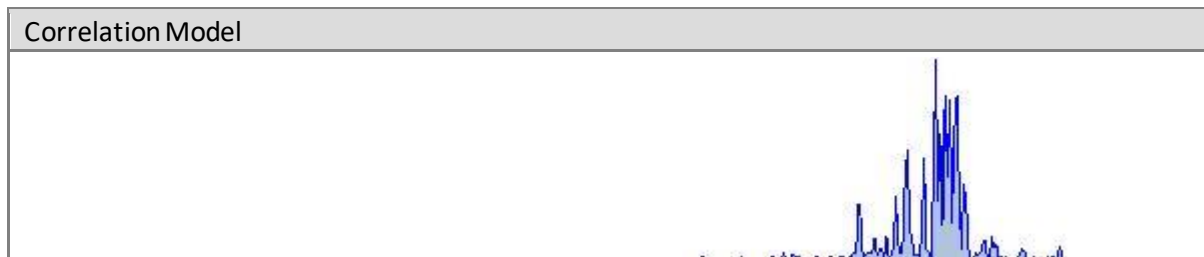
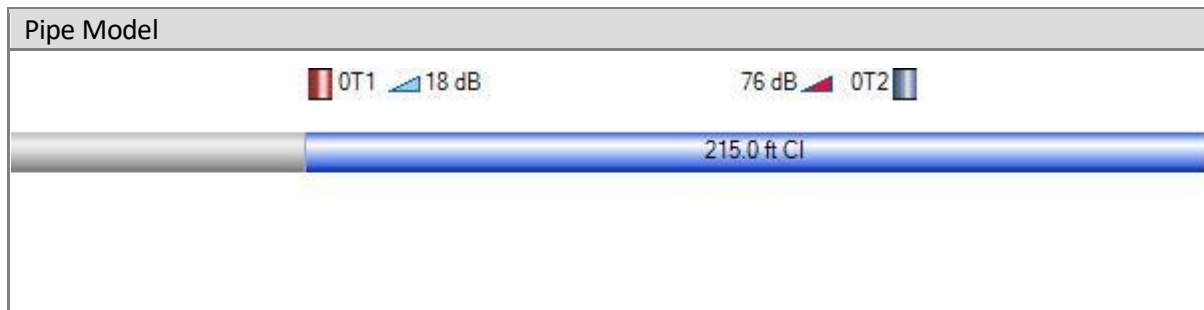
Test Details	Test Date	Report Date	Site
	6/25/2021	6/29/2021	VDEC 2021 / VTC FARM / 062521

Loggers	ID	Location
	OT1	Hydrant valve for 6" line on Water St
	OT2	Meter pit located at VTC Cattle Barn

Pipes	Length (ft)	Material	Diameter (in)	Velocity (ft/s)
	215.00	Cast Iron	6.00	4002.62
