New England Water Distribution Services, LLC Comprehensive Leak Detection Survey Report Randolph Center, VT

Performed on 5/22/17 and 5/23/17

Leak Detection Survey Daily Report

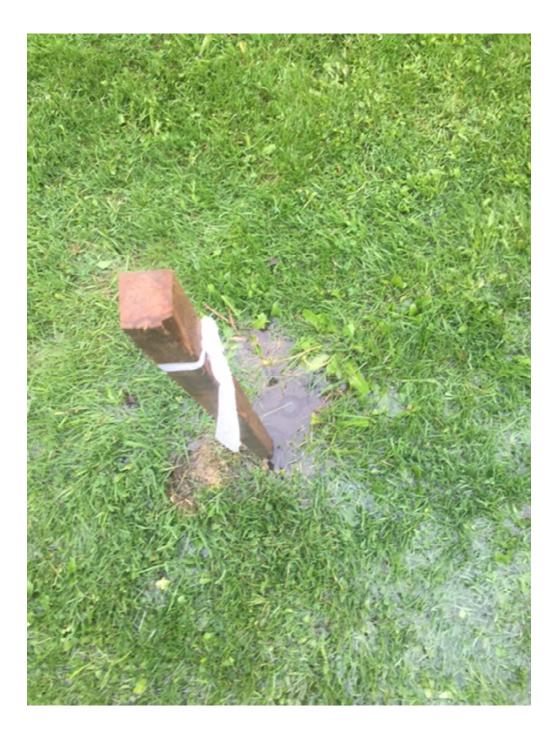
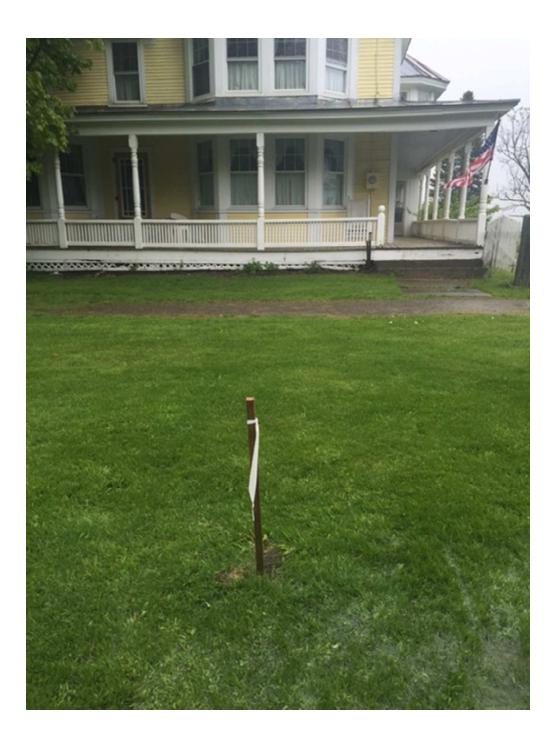
2980 Vermont Route 66

Weather:	Cloudy Rain 48 degrees F wind 5-10 mph.
Miles Surveyed: (approximate)	10:30 am - 5:00 pm
Type of Pipe Surveyed:	Ductile Iron, Cast Iron, Copper, PVC, Transite.
Suspicious Areas:	None
Leaks Located:	<pre>2980 Vermont Rte 66 leak in the 1 1/2" copper service (11 GPM). 209 East Bethel Rd. First Congressional Church leak in the service line, curb stop will not turn, (4 GPM). 21 Water St. Service line leak (5 GPM) house side of the curb stop.</pre>
Leaks Pin-Pointed:	Same as Leaks Located
Additional Comments:	None

#(See below)	Leak Address	Type of Leak	Leakage Amount: Gallons Per Minute (gpm)	Date Found	Date Pin- Pointed
1	2980 Vermont Rt 66	Copper Service	11.0	5/22	5/22
2	209 East Bethel Rd. First Congressional Church	Service Line	4.0	5/22	5/22
3	21 Water St.	Service Line	5.0	5/22	5/22
4	Outside Nutting Building	Gate Valve	6.0	5/23	5/23
	TOTAL Leakage Per Minute:	26 GPM			
	TOTAL Leakage Per Day:	37,440 GPD

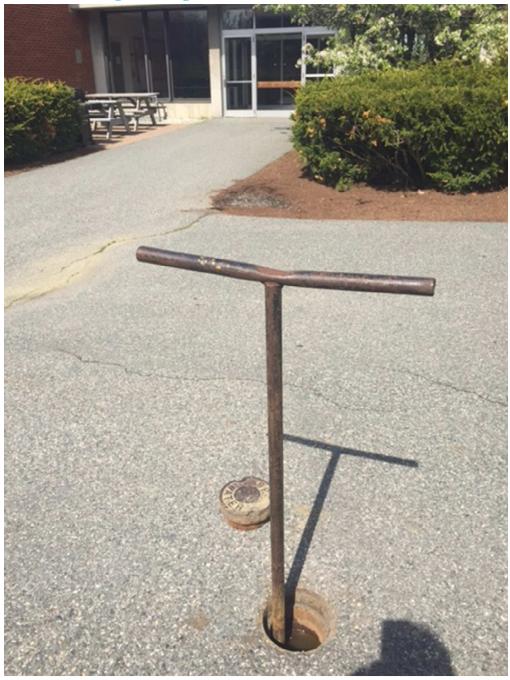
Outside Nutting Building

Weather:	Partly cloudy 68 degrees F wind 0-10 mph
Miles Surveyed: (approximate)	9:30 am - 4:00pm.
Type of Pipe Surveyed:	Ductile Iron, Cast Iron, Copper, PVC, Transite.
Suspicious Areas:	None
Leaks Located:	Vermont Technical College - Outside the Nutting building 6" gate valve leak (6 GPM).
Leaks Pin-Pointed:	Same as Leaks Located
Additional Comments:	None
