Water Asset Management Plan for RANDOLPH CENTER WATER SYSTEM RANDOLPH, VERMONT July 30, 2021

DUFRESNE GROUP CONSULTING ENGINEERS Submitted to: Randolph Fire District #1 Vermont Technical College

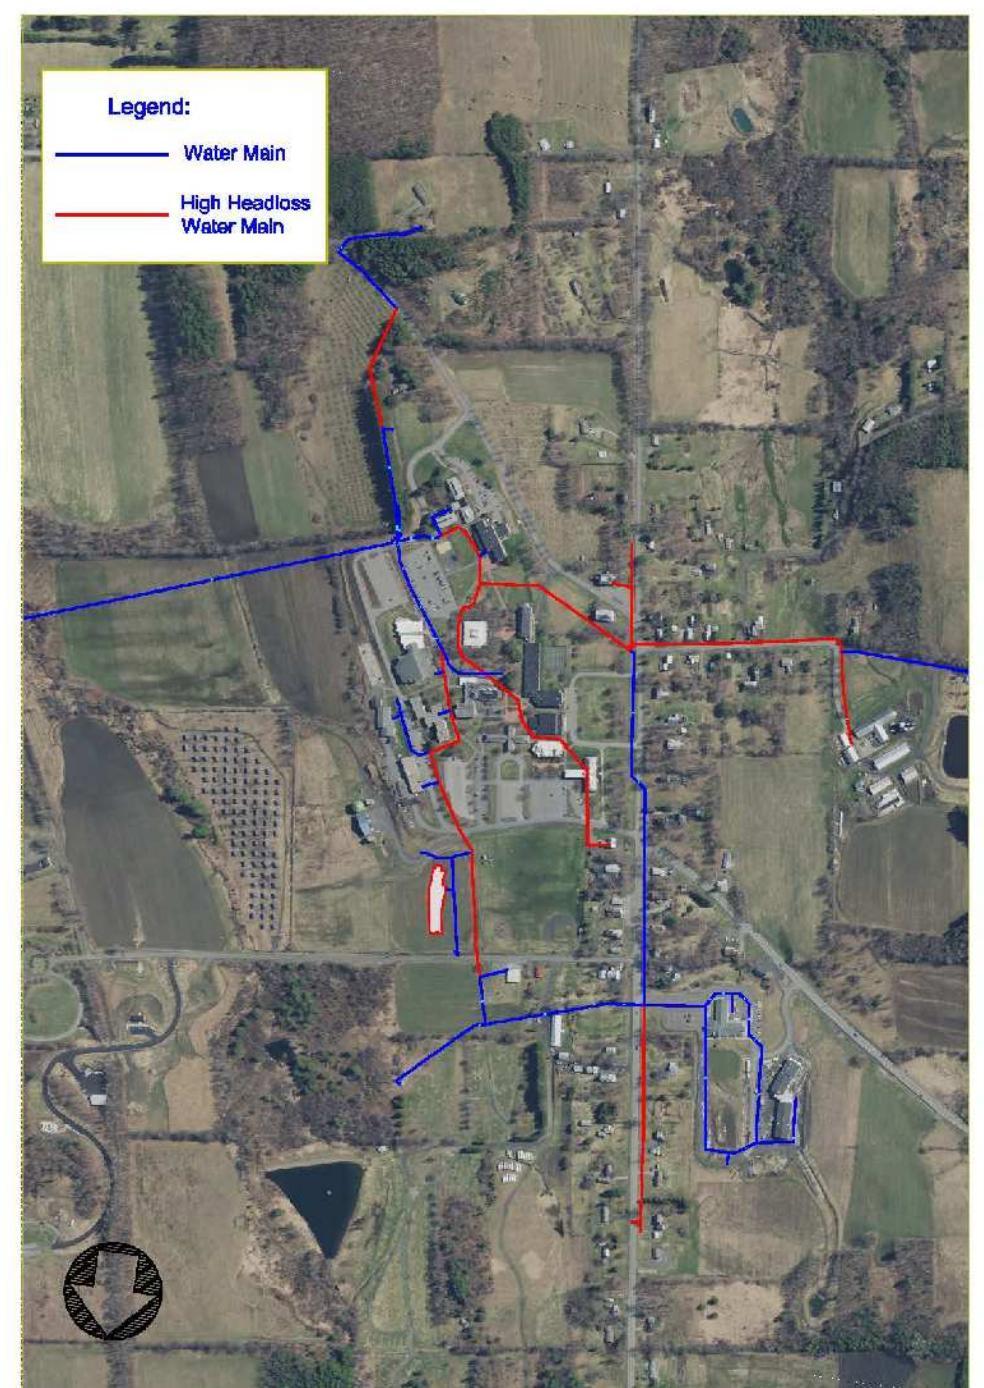
Figure 3-1: Headloss deficiencies for maximum day demand with 500 gpm fire flow.

During conditions of maximum daily demand (78,500 gpd) in conjunction with fire flows¹ there are some pipes with high headloss. **Figure 3-1** shows pipes with high headloss, specifically over 6 ft/1,000 ft, with simulated fire flows of 500 gpm during maximum day demand. **Figure 3-2** shows high headloss pipes during maximum daily demand with 1,500 gpm fire flows.

The hydraulic results showing high headloss during fire flow conditions are not sufficient information to rank the high headloss pipes as deficient or in need of replacement. A complete hydraulic evaluation is necessary to develop recommendations for replacing water mains or completing other improvements to address hydraulic deficiencies. System improvements may be identified to resolve inadequate fire flows, but would not be recommended solely to eliminate high headloss conditions.

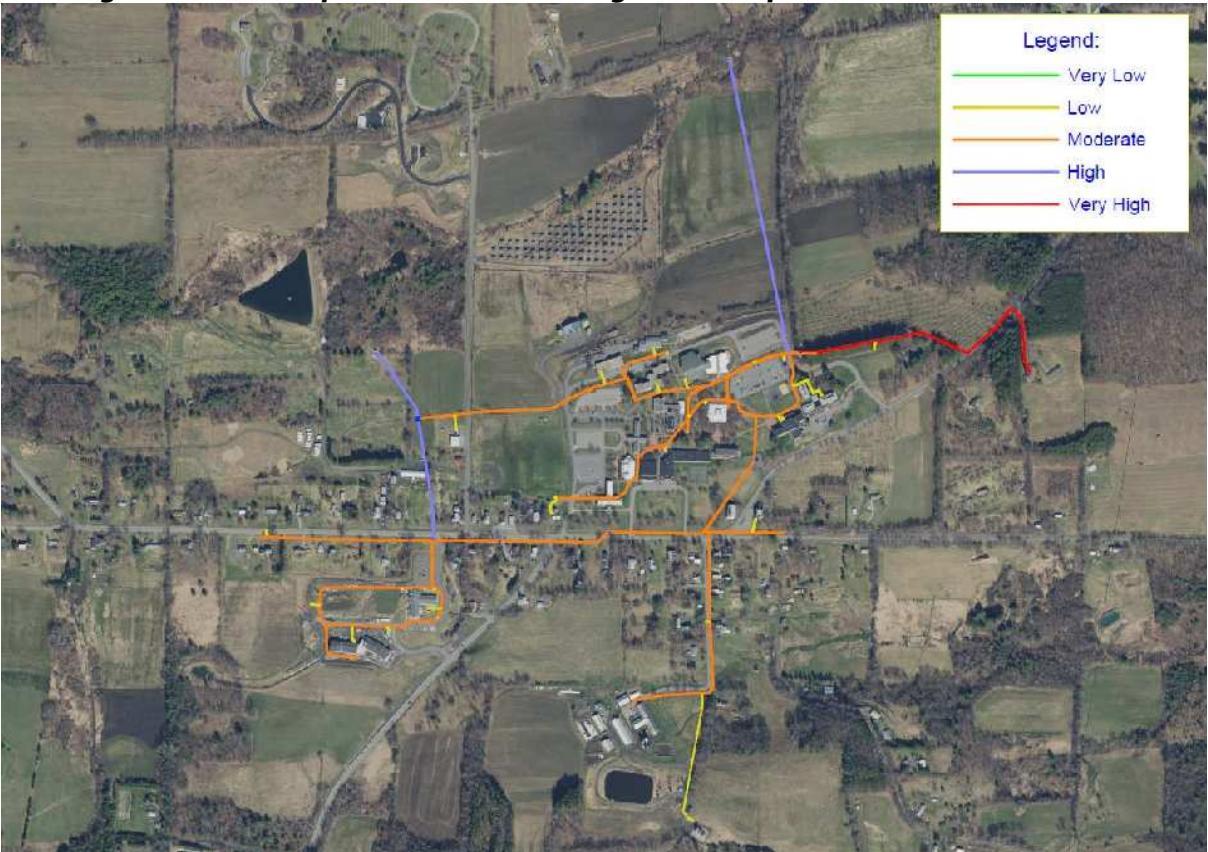
Figure 3-3: Consequence of Failure Assignment Map

The Randolph Center Water System operates only one storage tank, which is critical to system operation. The consequence of failure of the tank or the tank transmission main is Very High or 5. The source transmission mains have a lower COF rating of 4, considering there is not a single source and the tank provides storage to meet system demands for a limited time.

In comparison to storage and source, failure of water distribution system individual components may impact customers in discrete locations and are generally not as critical to the operation of the entire system. The assigned COF for most pipes is 3. Hydrant leads and other short segments serving few customers have COF values of 1. **Figure 3-3** shows a map of the water distribution system with the assigned COF values.

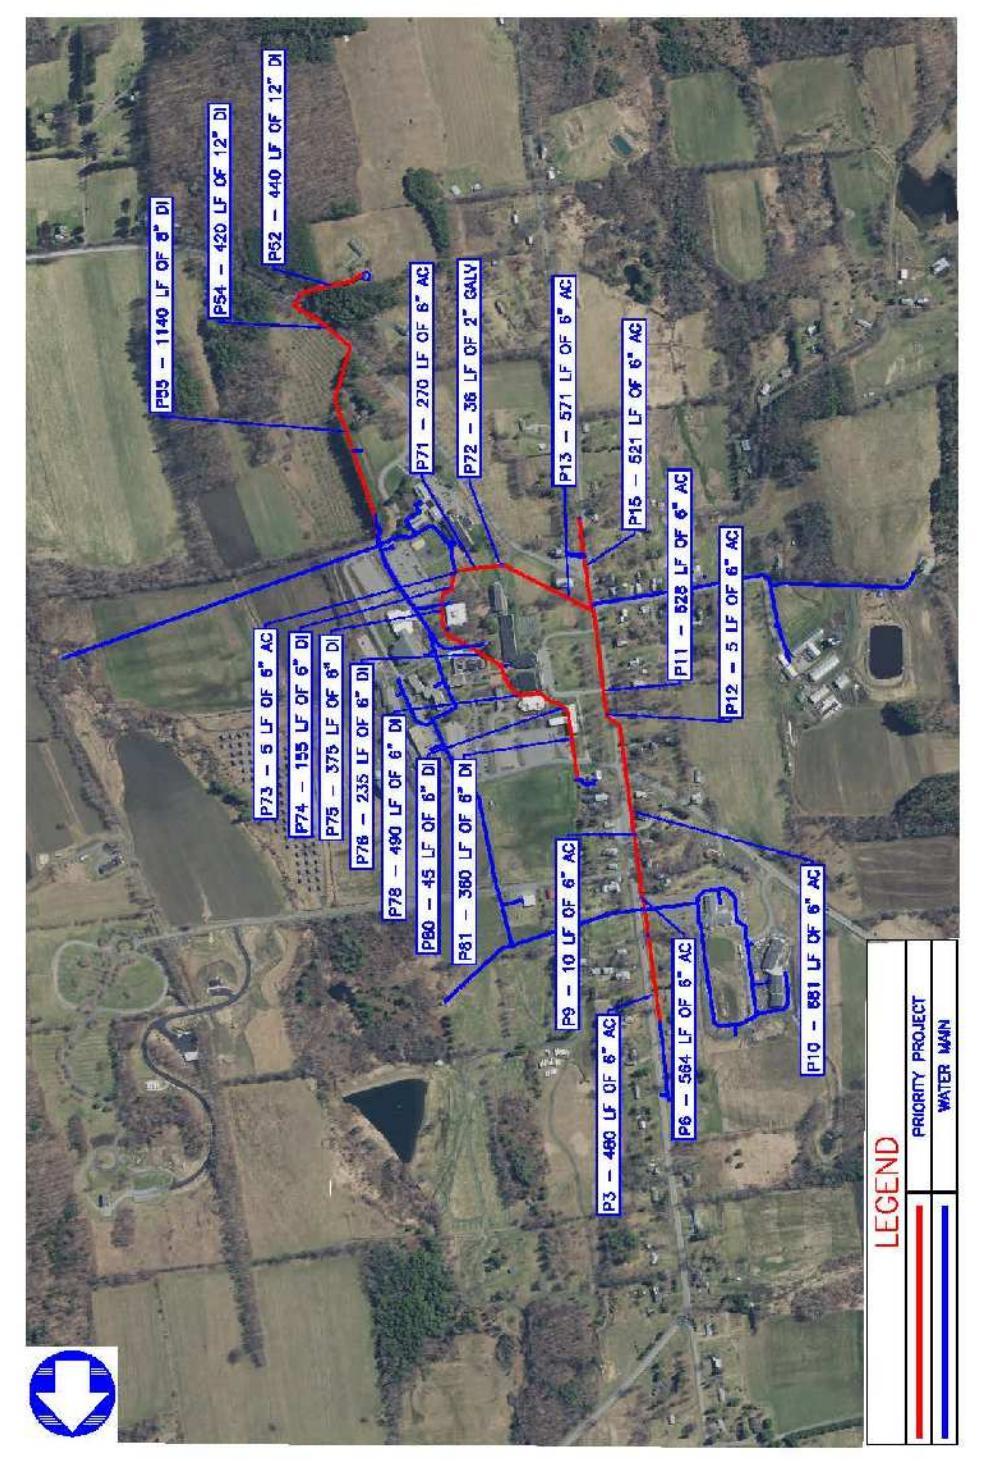
Figure 3-4: High Risk Water Mains

A risk factor of 10 or above is considered High Risk. A risk factor from 5-10 is considered Moderate Risk. Risk factors below 5 are considered low risk. **Tables 3-4 to 3-6** show the risk assessments. Assets highlighted with grey represent assets with a remaining expected useful life of 10 years or less. **Figure 3-4** shows the location of the high risk water mains.

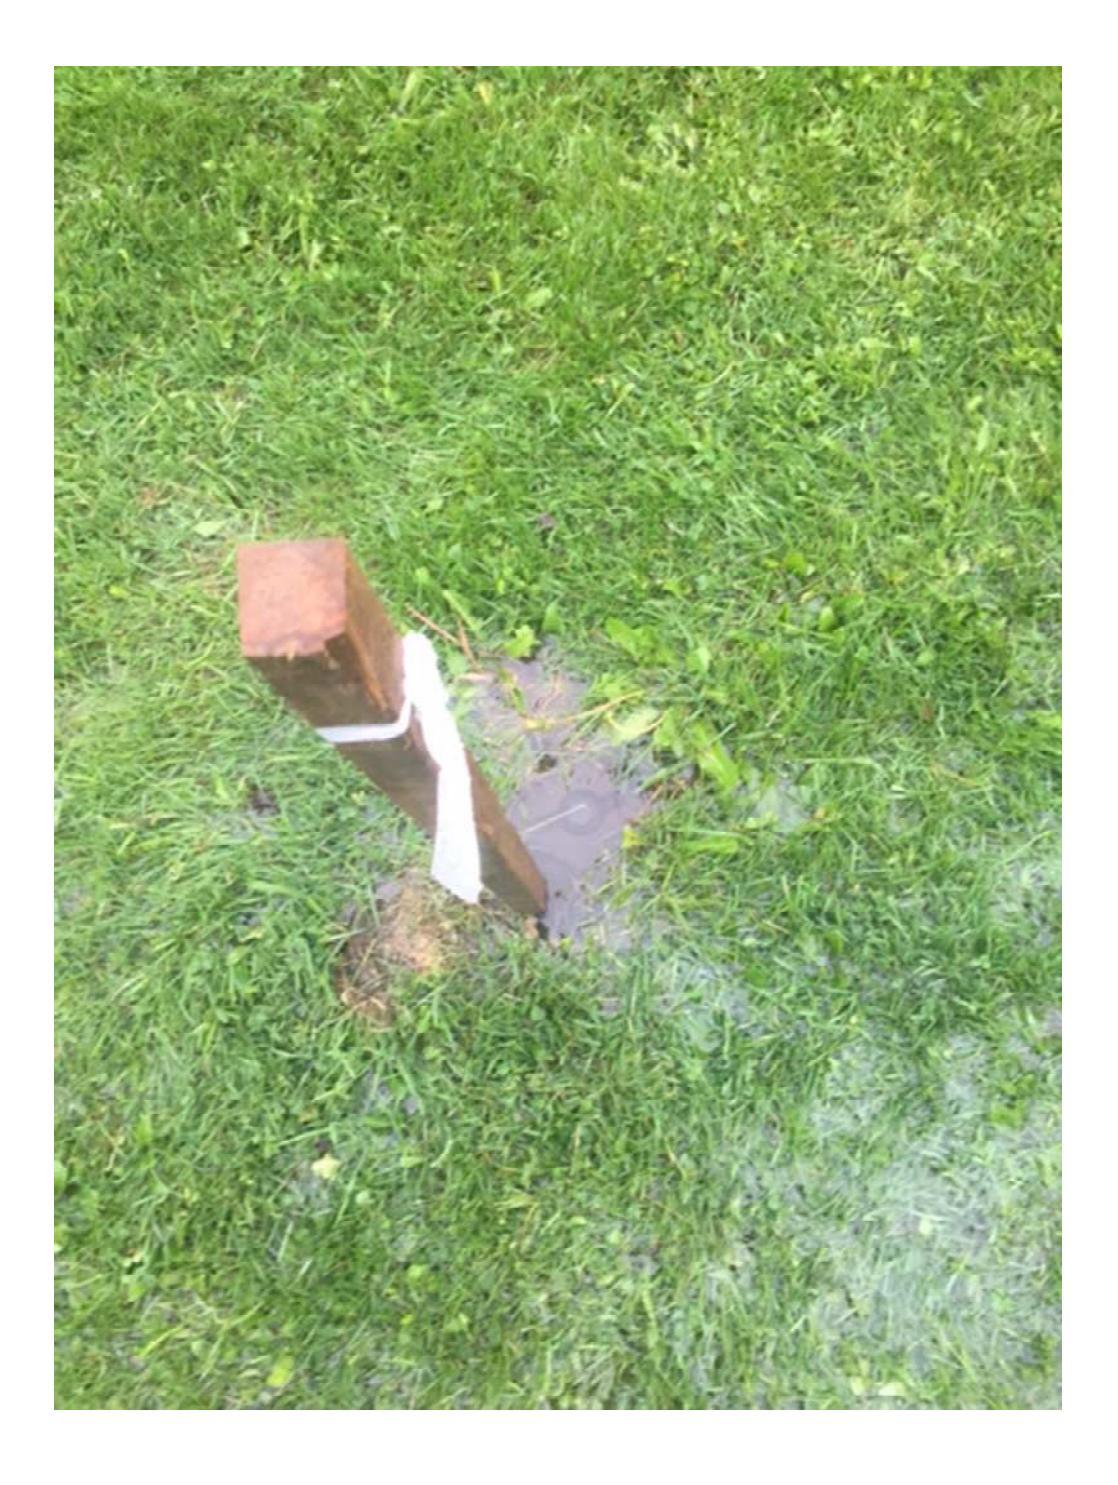
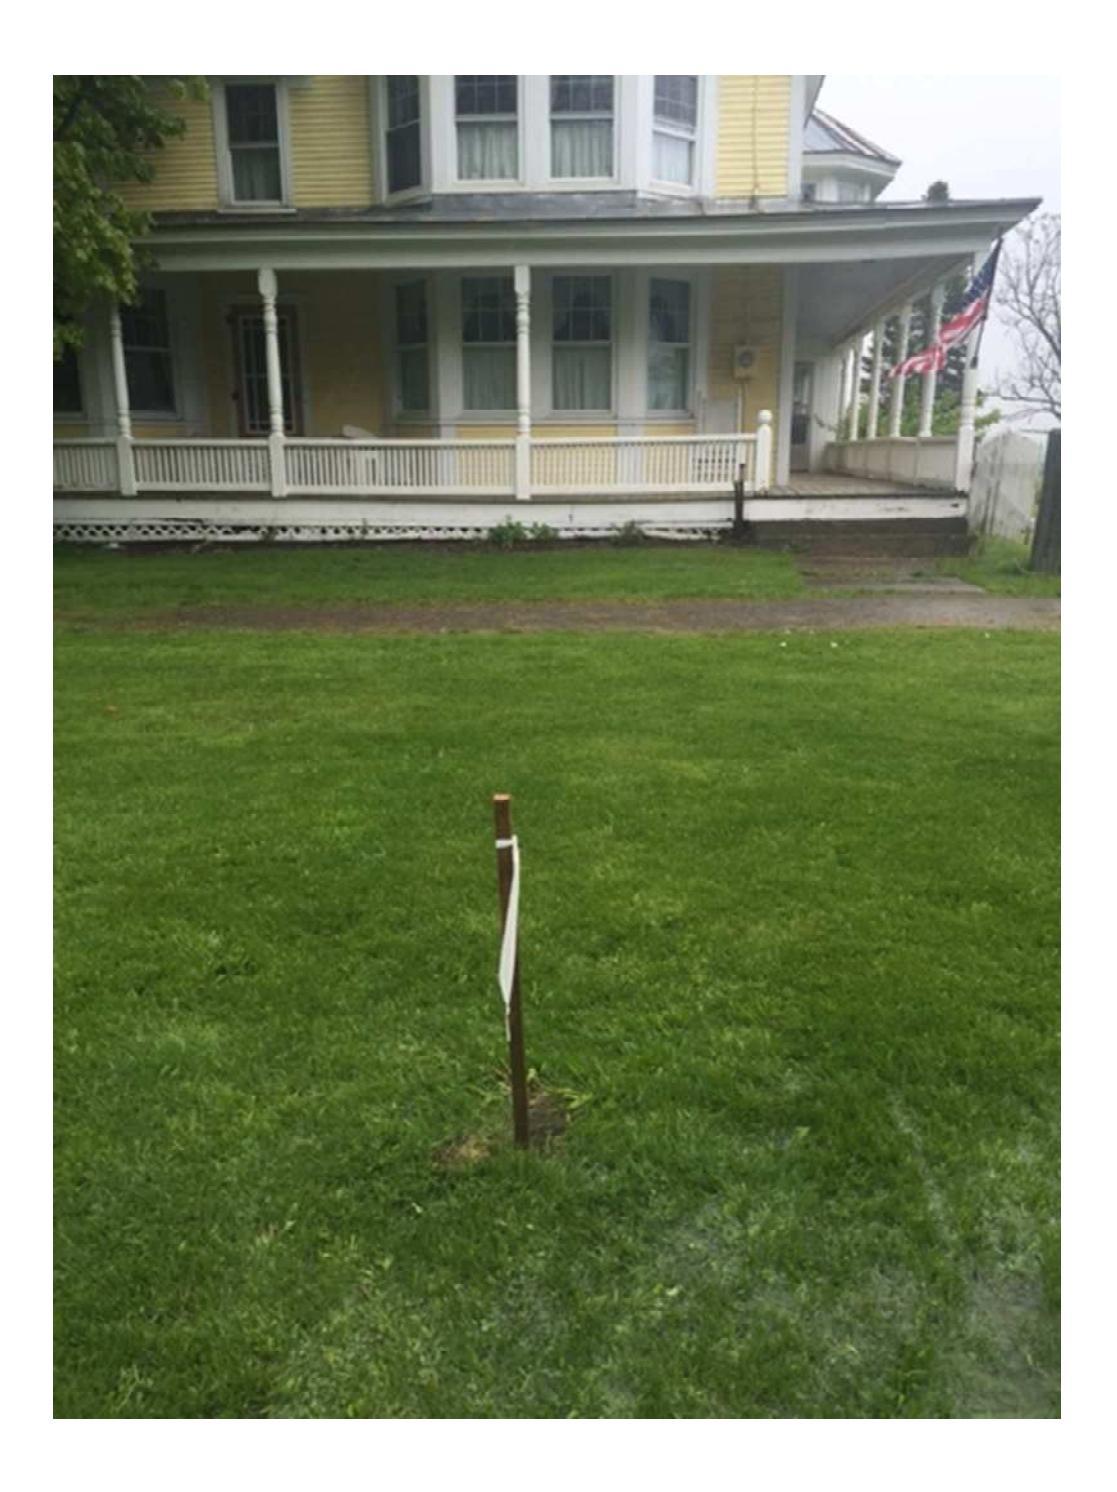
2980 Vermont Route 66

Based on the survey results, which are included in the Appendices with an email summary by William DeFlorio, leaks were detected on three service lines and at a gate valve. The leak detection results did not affect the condition ratings of pipe assets since the leaks are on services (which are not water system assets beyond the curb stop) and at one discrete location on a single pipe, P43-VTC, a 50 year old 4" diameter ductile iron pipe adjacent to Nutting Hall.
