The 2021 (VDEC) Randolph Center, VT - LDS Project included (2) days of contracted leak detection services within the distribution system. The survey provided coverage on the entirety of the town as well as VTC owned assets due to the shared system between both entities.

### Leak Card 1

# Enigma Test Report

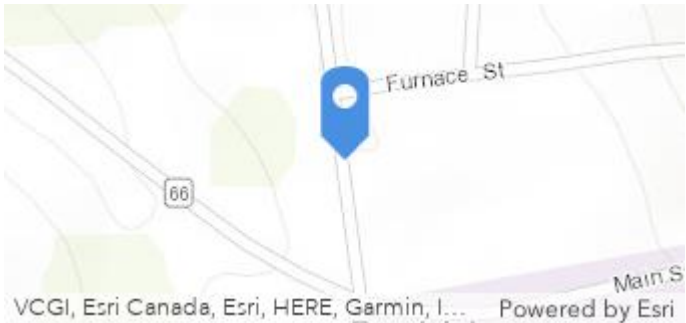
<b>Gallons Per Day:</b>		144						
	<b>Gallons Per Month:</b>		4,380						
	<b>Gallons Per Year:</b>		52,560						
<b>Leak Description &amp; Comments:</b>									
Fitting leak detected via sounding equipment. Further probing inspection found water signatures inside the valve casing. Leak appears to be at or near the valve assembly.
